Inspection Report

CW-20120322-DUPRO-001

Client Name: Consorcio prisma	
Product Name: Seamless Carbon steel pipes	
Inspector: Jack Xu	
Report approver:	
Inspection type: DUPRO	
Inspection location:	CANGZHOU, HEBEI, CHINA
Inspection date:	22/Mar/2012
Your reference number: N/A	
P/O number: HB2011-12-05	
Buyers: Consorcio prisma	
Supplier: Heibei Zhonghai Steel Pipe Manufacturing Corporation	
Order quantity:	2607.8m/221pcs
Pcs ready for inspection:	2607.8m/221pcs
Reference sample available:	N/A

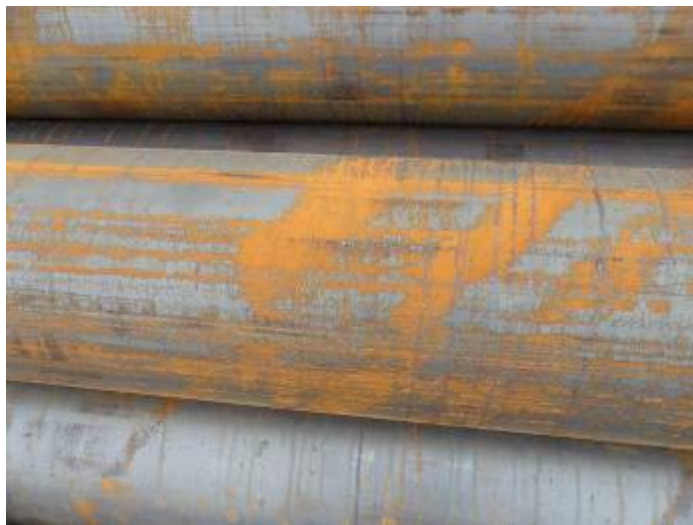
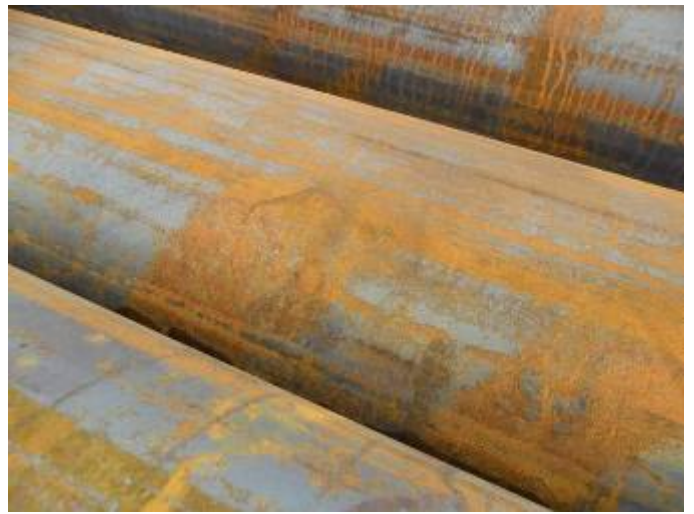
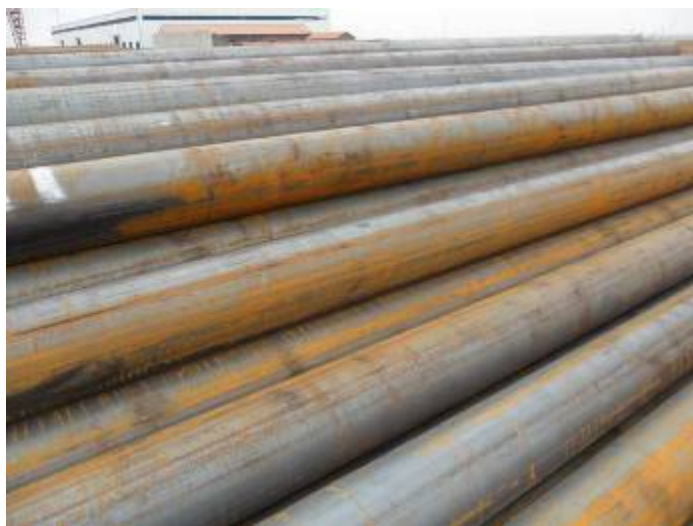
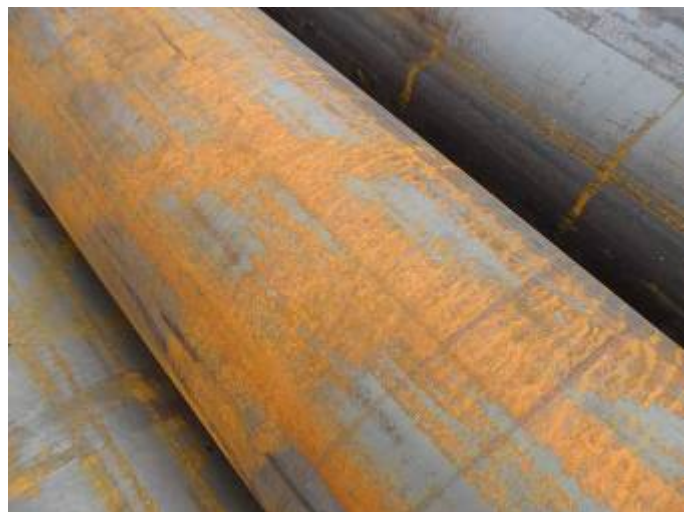
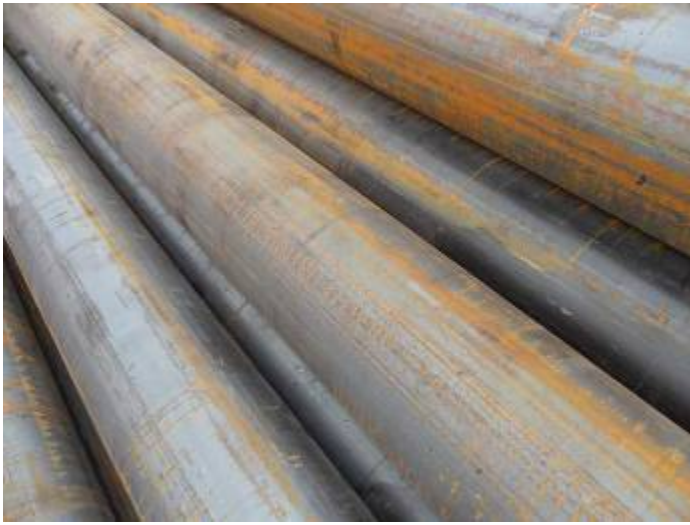
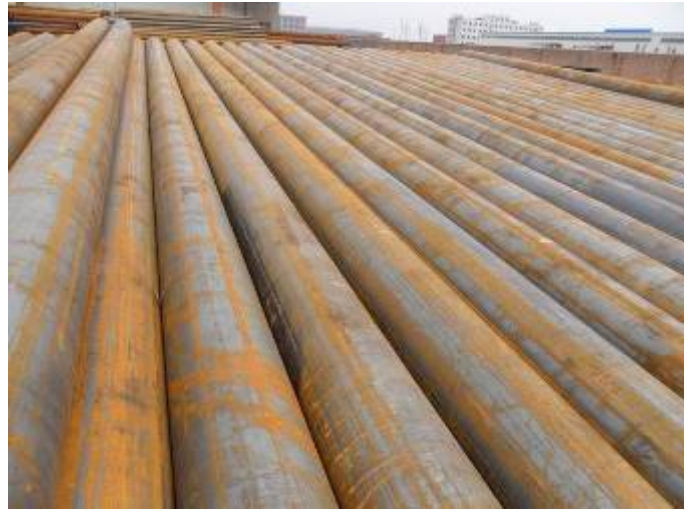
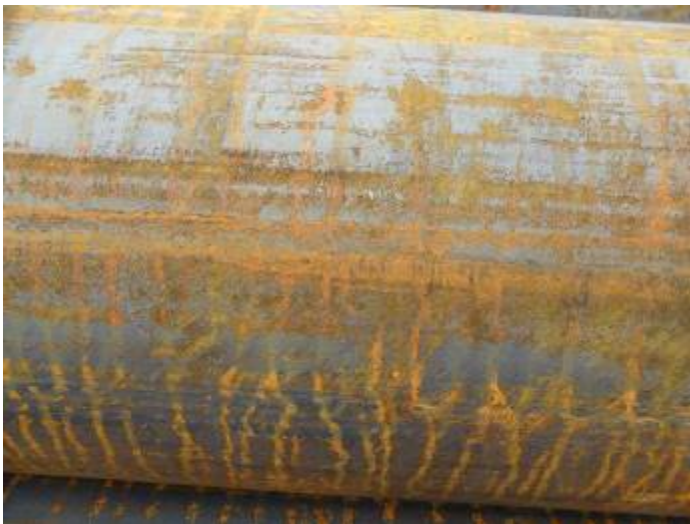
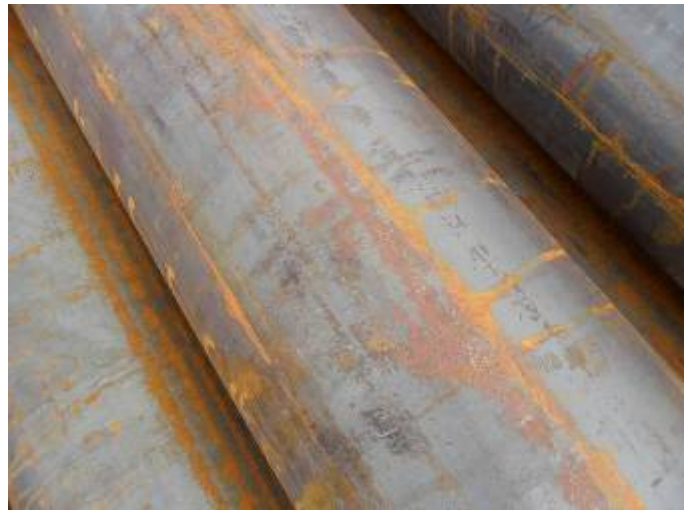
Found the product surface has obvious rust due to the rain at outdoor. Please see the photos and confirm whether it is accept or not.

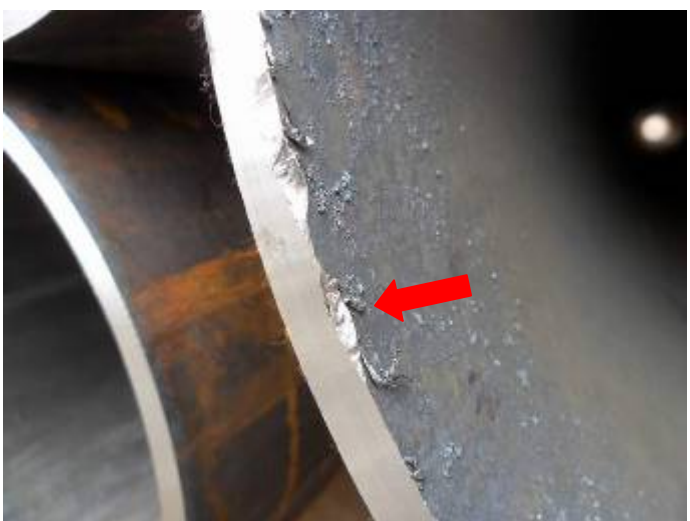
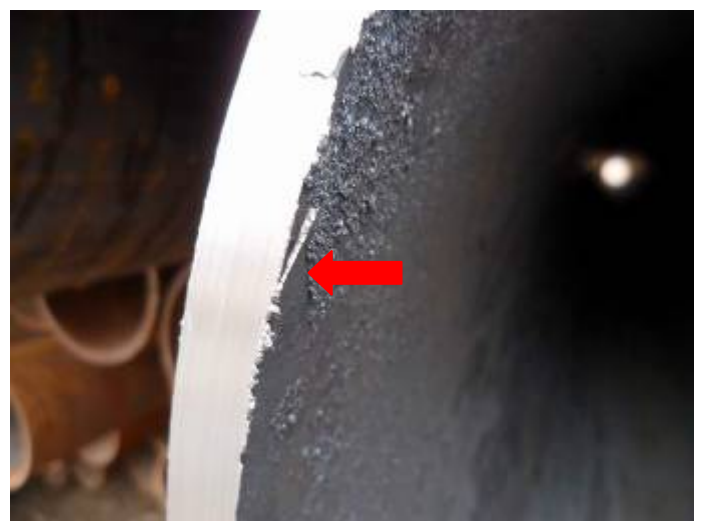
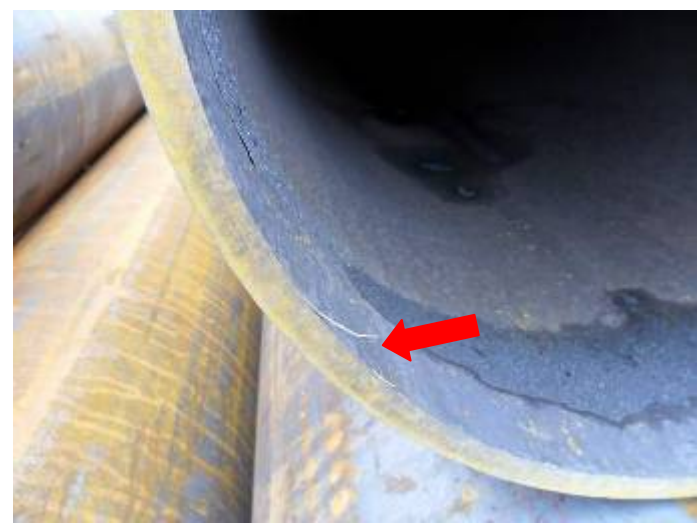
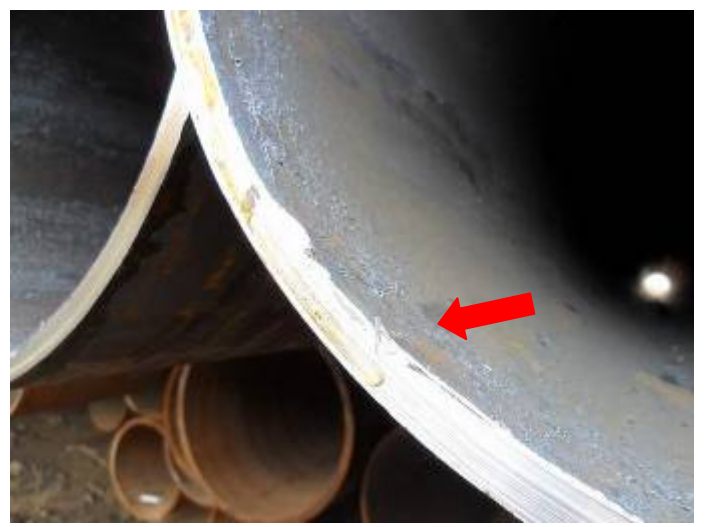
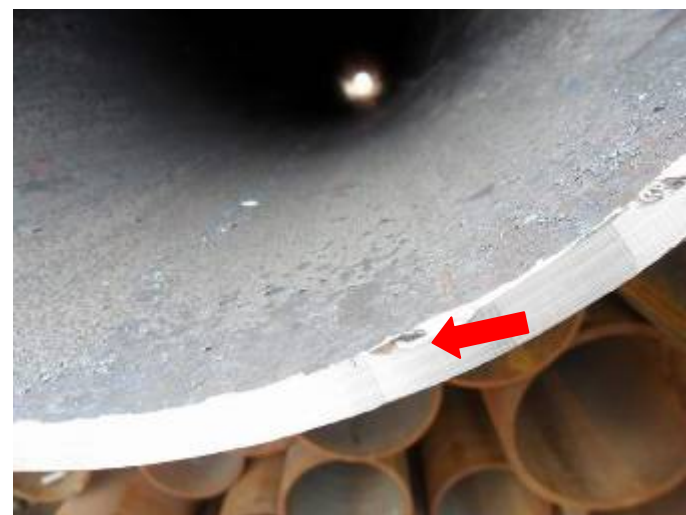
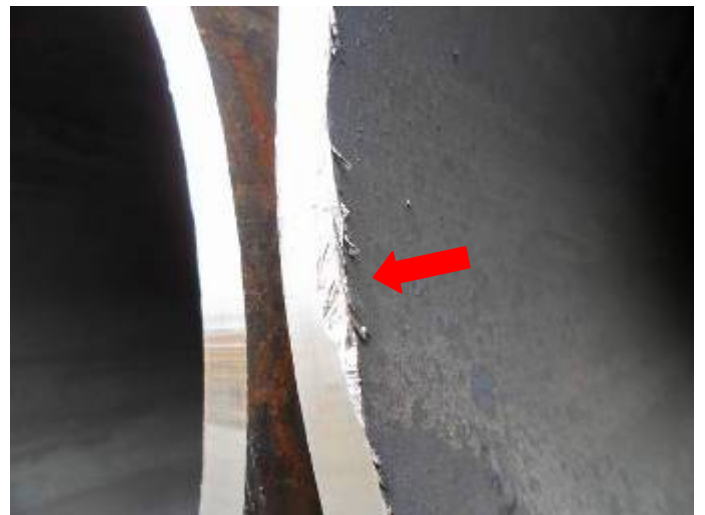
Confirm it is plain end on both sides. Found there were many sharp burr on plain ends. Required the factory should clear the sharp burr on plain ends before the inside surface is coated the epoxy resin paint.

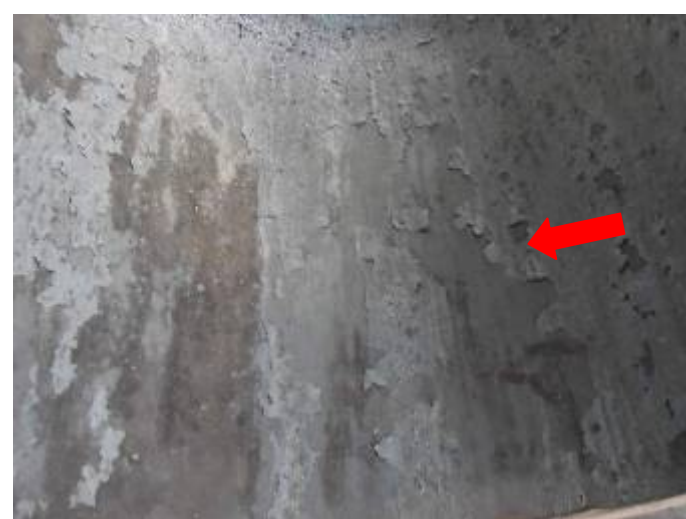
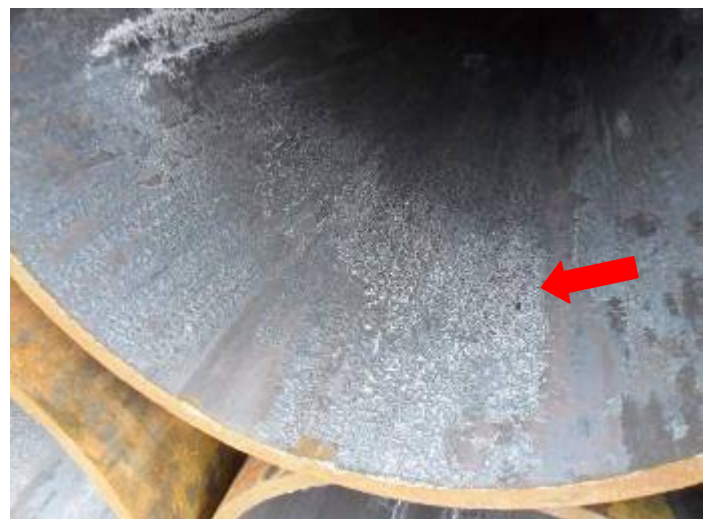
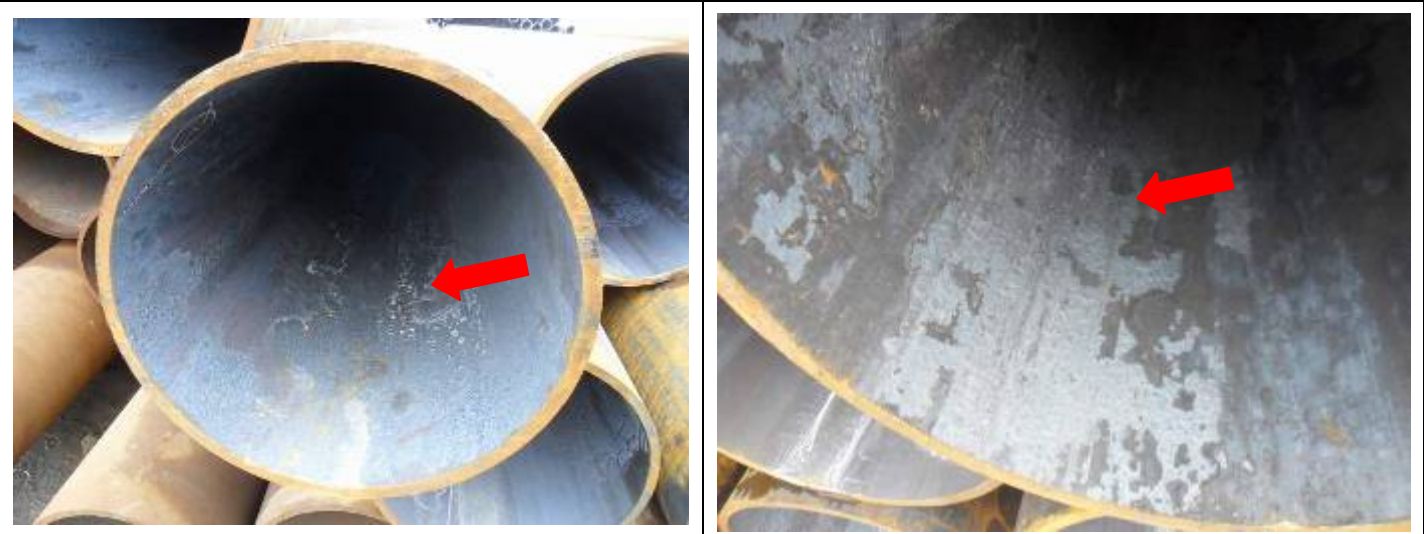
Found there are many oxide films on inside surface. Required the factory should clear these oxide films before the inside surface is coated the epoxy resin paint.

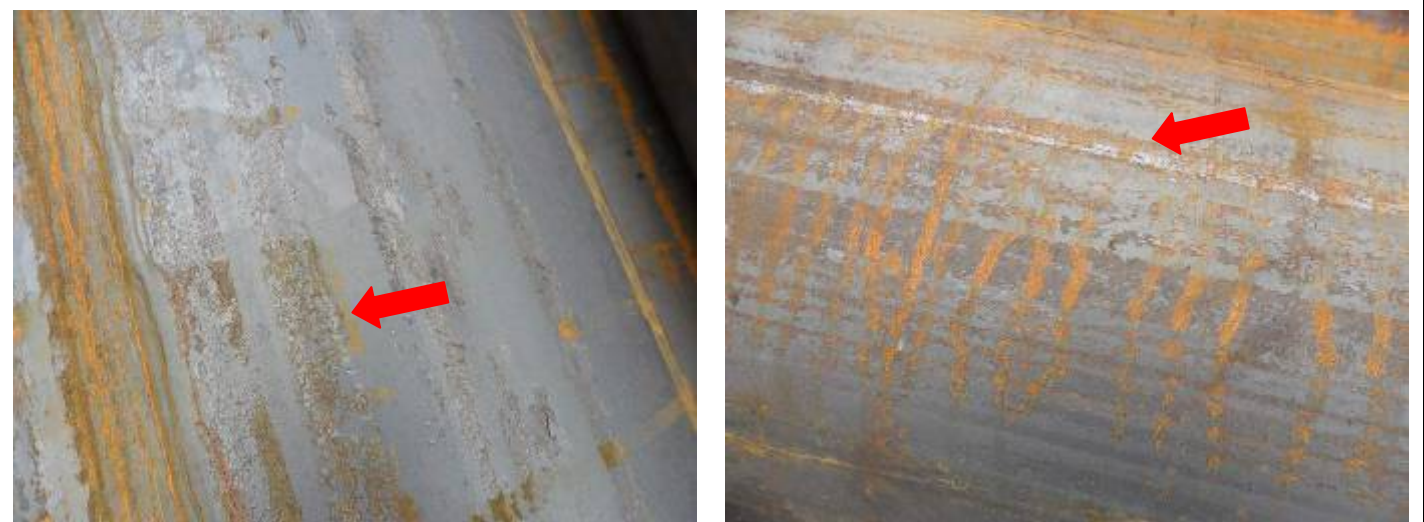
Minor : Few oxide films on outer surface. -2pcs

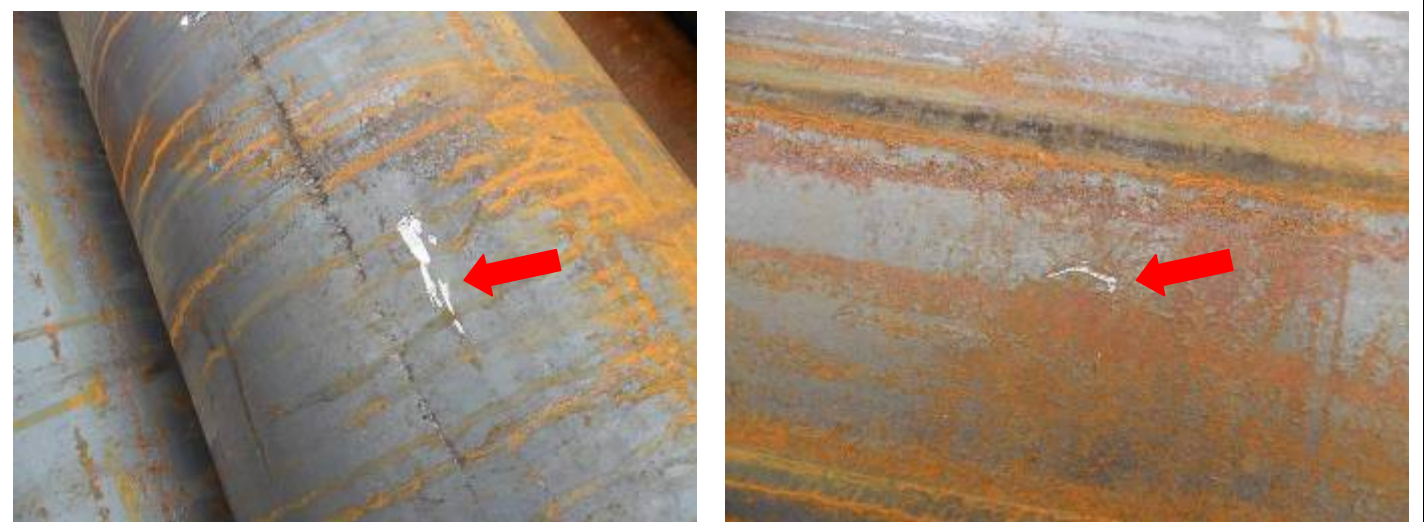
Minor : Scraped surface.-2pcs

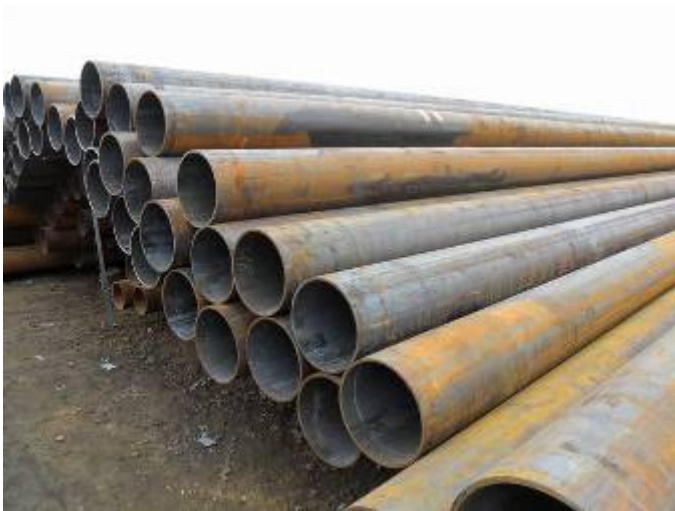
1. Finished semi-products on outdoor

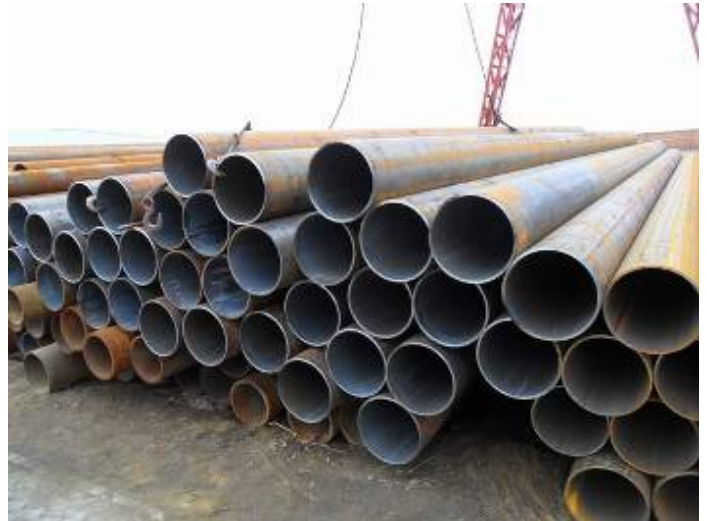
2. Finished semi-products on outdoor

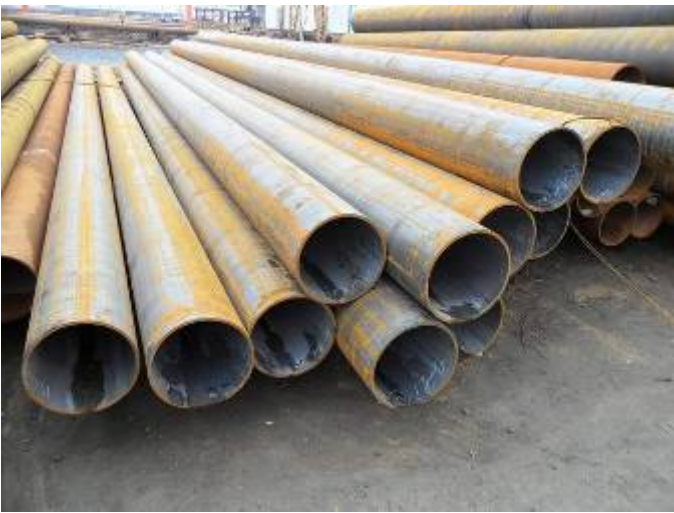
3. Finished semi-products in outdoor

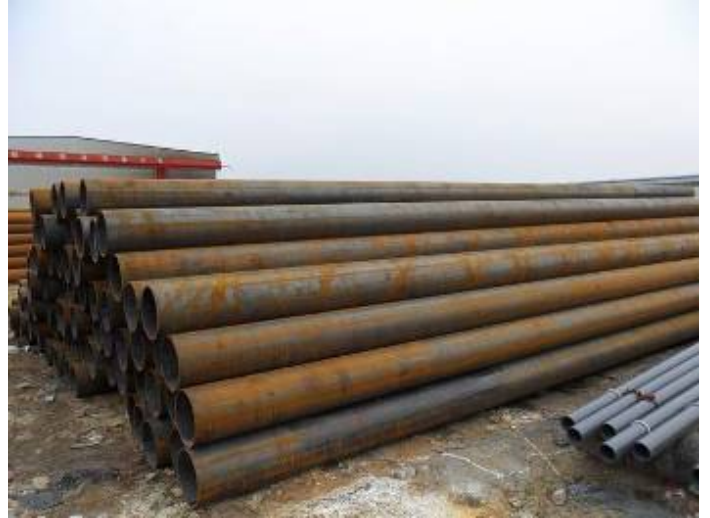
4. Finished semi-products in outdoor

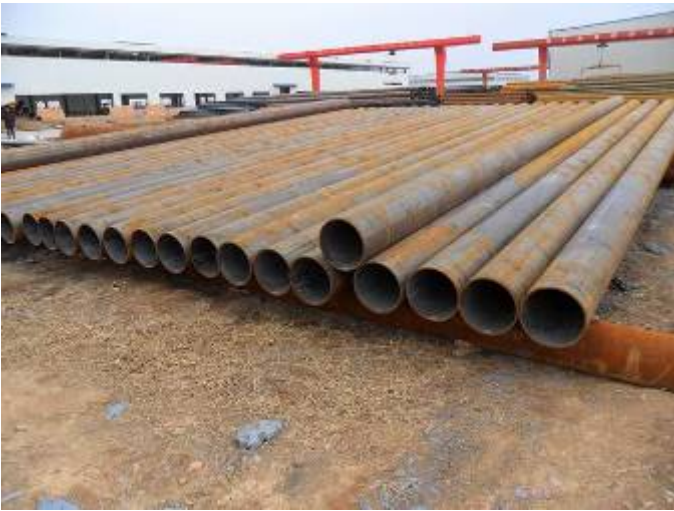
5. Finished semi-products on outdoor

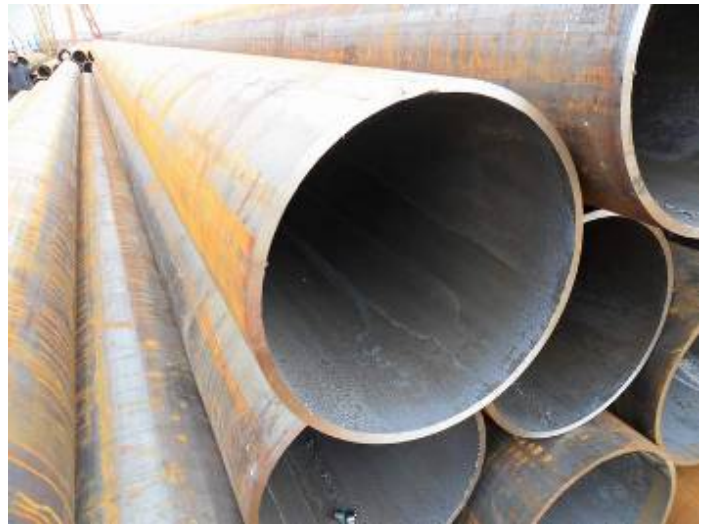
6. Plain ends on both sides

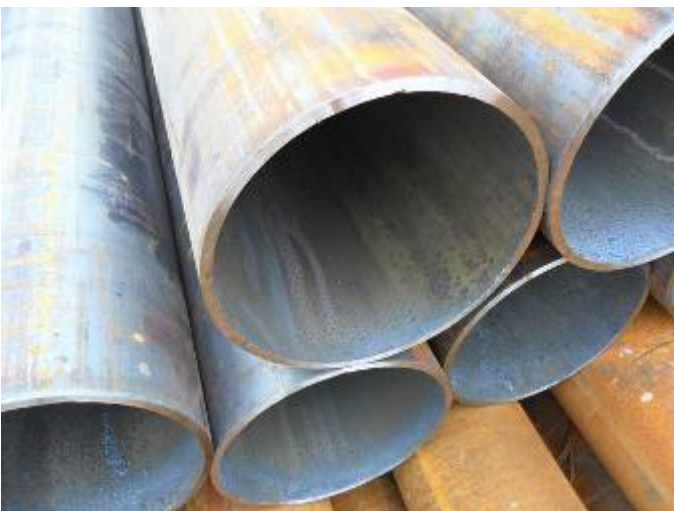
7. Plain ends on both sides

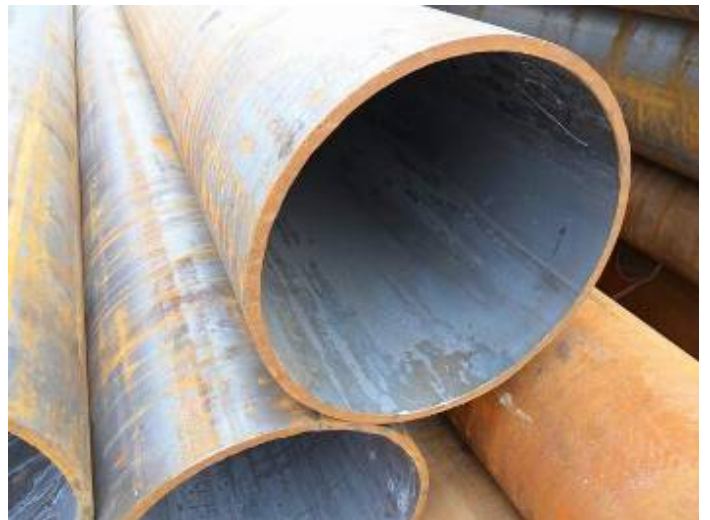
8. Plain ends on both sides

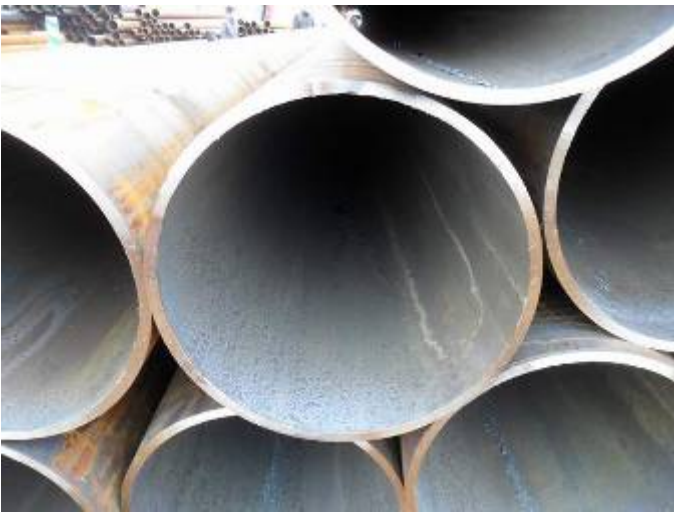
9. Plain ends on both sides

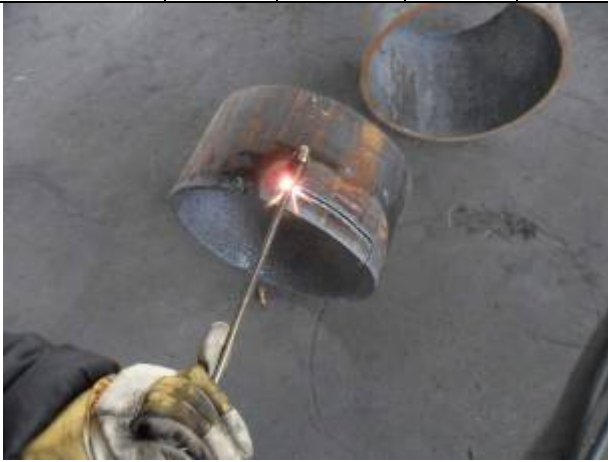
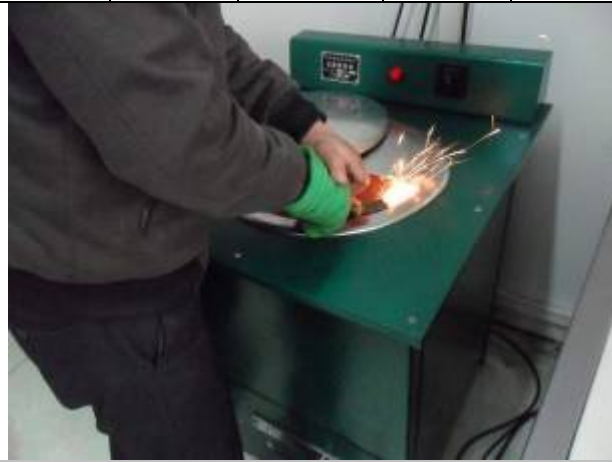
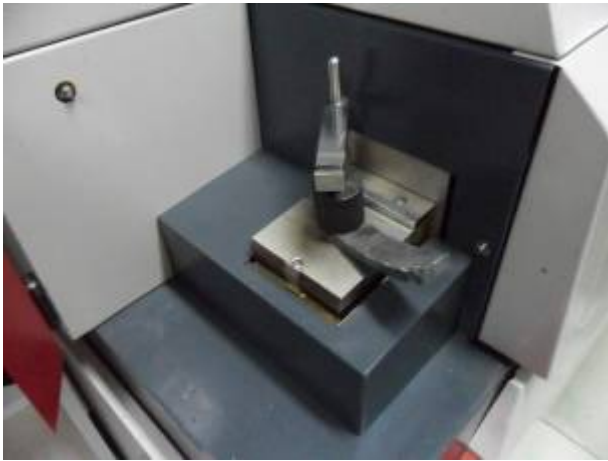
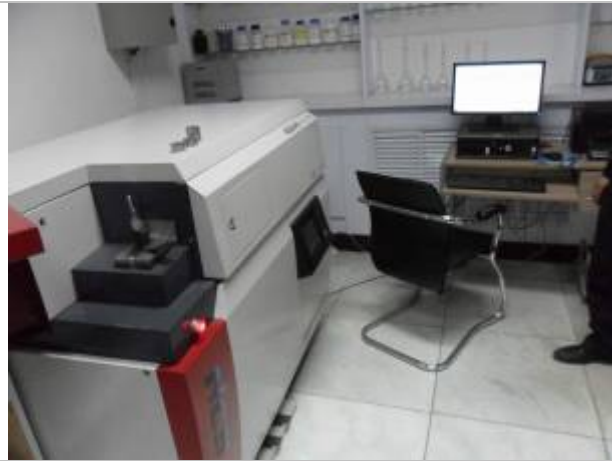
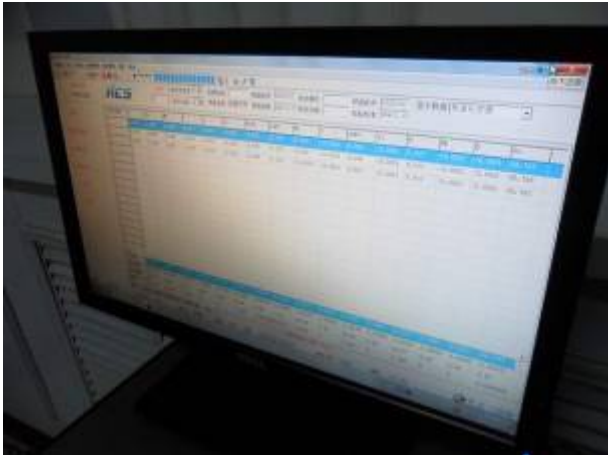
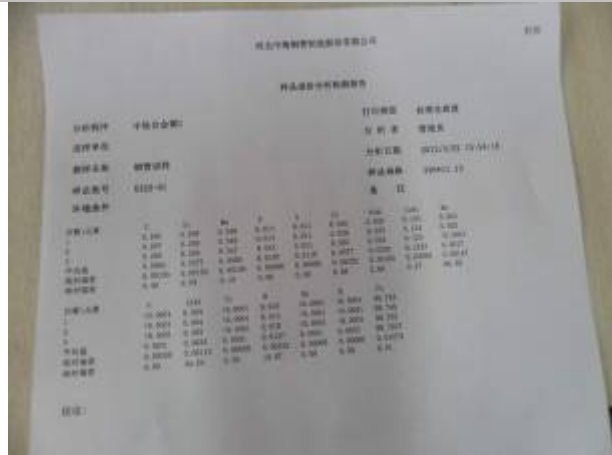
2. Product Flattening Test: -2 pcs

Confirm without developing cracks

Passed

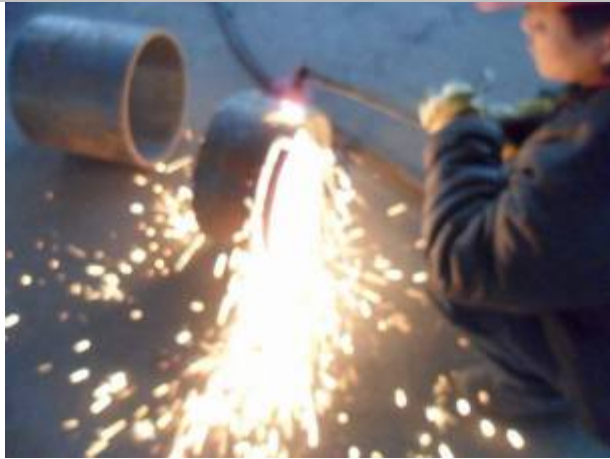
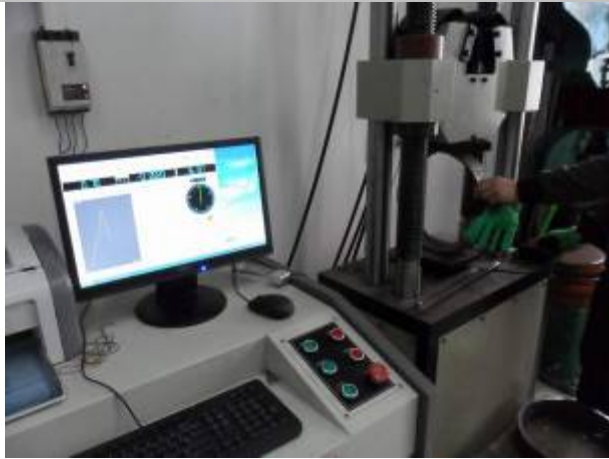
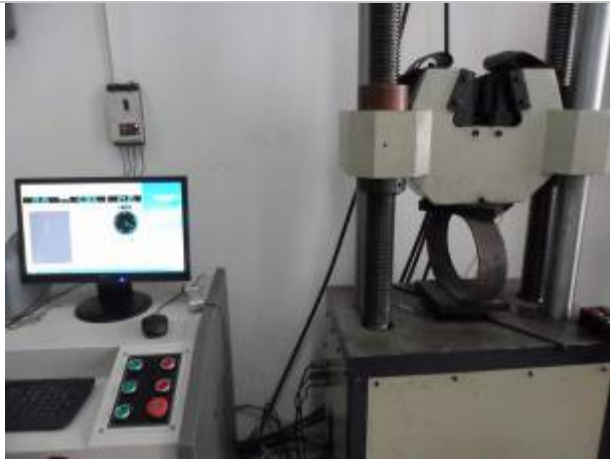
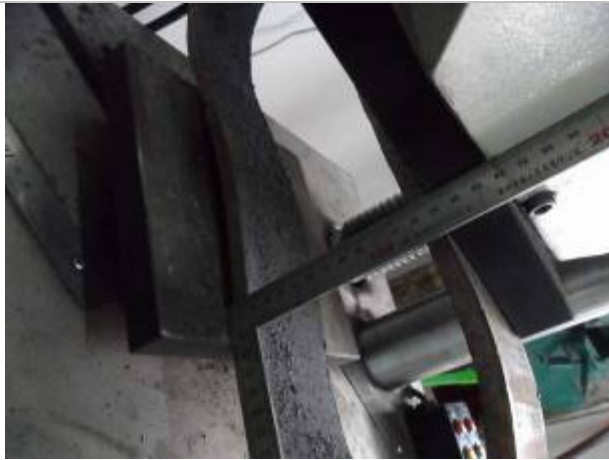
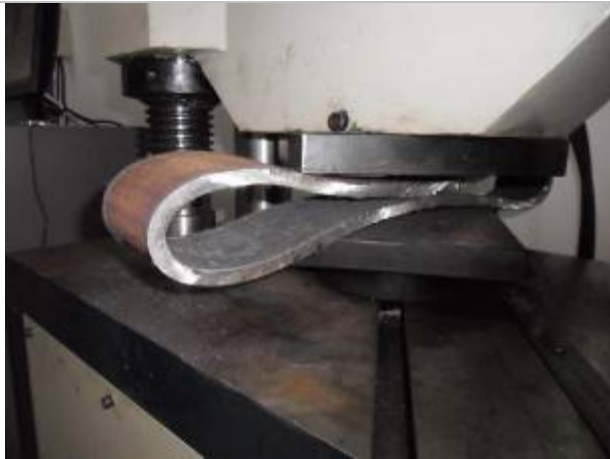
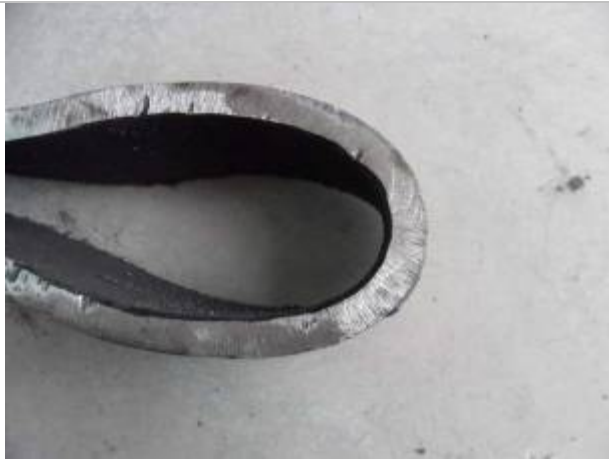
3.Pull test --S1

Check 1pc per items

passed
