Inspection Report

CW-20120319-CLS-001

Client Name: Sultan Triveni General Trading & Contracting	
Product Name: POF centerfolded film	
Inspector: Richard Li	
Report approver:	
Inspection location:	SHENZHEN, GUANGDONG, CHINA
Inspection date:	19/Mar/2012
Your reference number: N/A	
P/O number: ST-044-2011	
Inspection type : Container loading supervision(CLS)	
Supplier: Hubei Guancheng Biodegradable Plastic Products Co. Ltd	
Vendor: Hubei Guancheng Biodegradable Plastic Products Co. Ltd	
Order quantity : 720Rolls	See attached table
Pcs ready for inspection:	100% ready
Reference sample available:	NO

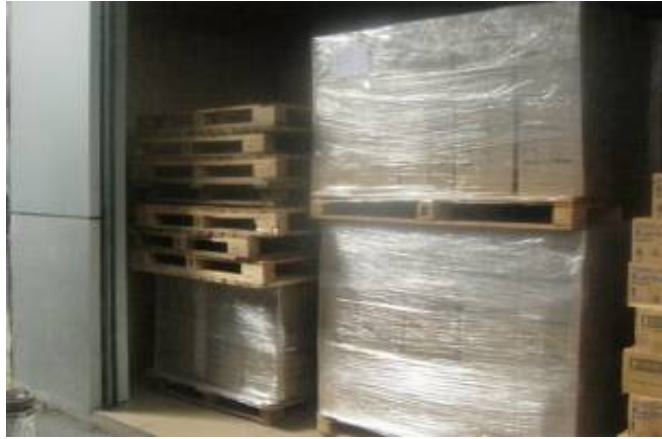
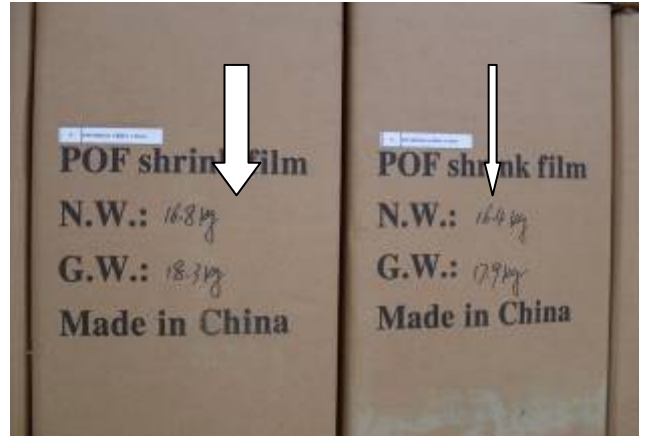
Remark photos

For all of items, actually found the net weight and gross weight were described differently on each of shipping box, but we could not check it due to no suitable equipment provided

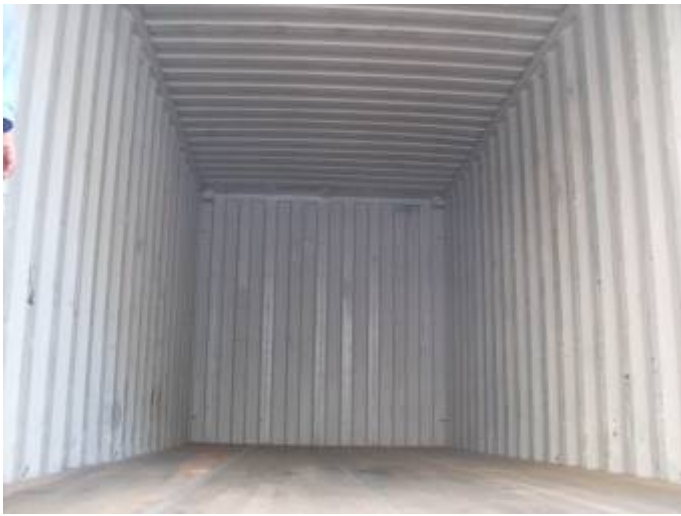
3. Loading Process	
Client's specific instructions for Loading Process :	
N/A	
EMPTY CONTAINER	
Requested Check	Actual Finding / Comments
Container general conditions : - water - rust holes - dust - grease - general cleanliness	- no water - no rust holes - clean - no grease
Container door numbers	HJCU2911605
Inside container numbers	
Outside container numbers

Empty container

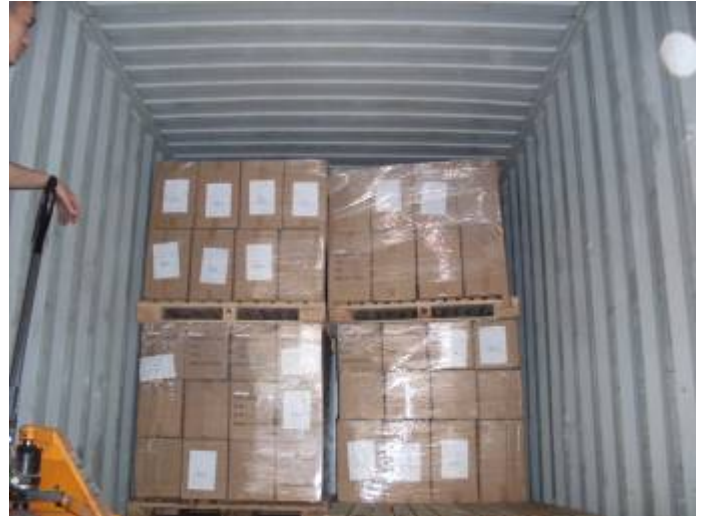
1/4 FULL CONTAINER	
Requested Check	Actual Finding / Comments
Loading method : - By hand or machine - Pallets or individual carton	-By hand & machine - Individual carton & pallets
Loading by the top or the back of the truck?	Loading by the back
Describe how the cartons are piled up (collapse risks)	Refer to photo below
How many layers of cartons inside the container ?	5 layers
Did any cartons fell on the floor during loading?	No

1/4 Full container

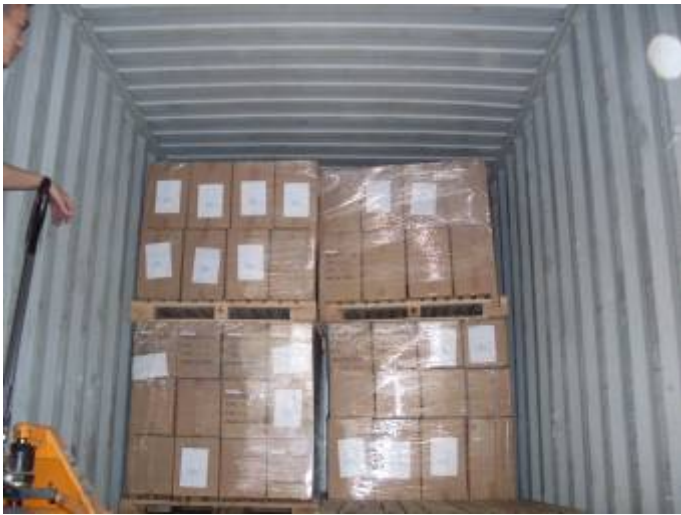
1/2 Full container

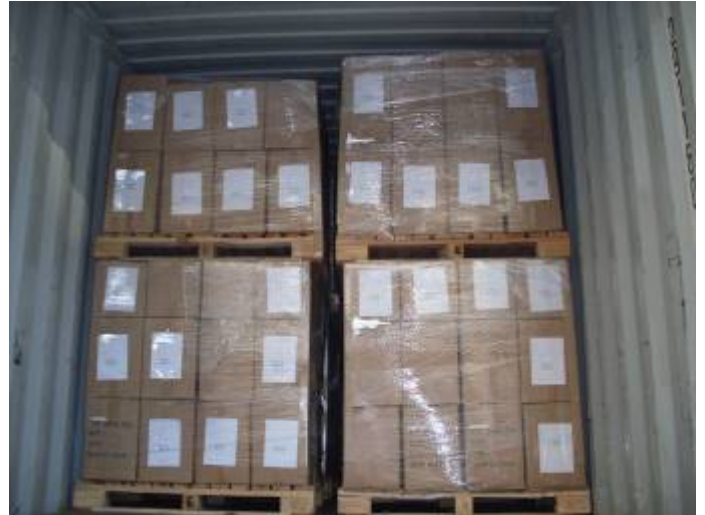
3/4 Full container

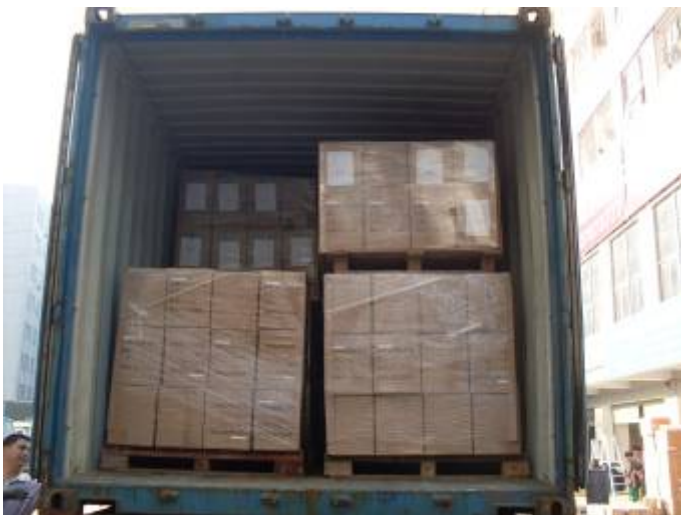
FULL CONTAINER	
Requested Check	Actual Finding / Comments
Is the container completely full? If no, describe how carton are tied together.	Yes, there is. The detail for reason pls. refer to remark and loading photos.
Is there any space between the top of the last layer of cartons and the roof of the container ?	Yes, there is. The detail for reason pls. refer to remark and loading photos.
Container(s) seals number	HAN JIN CH8316169
Did any cartons fell on the floor during loading?	No

Full container
