Inspection Report

CW-20120322-DUPRO-001

Client Name: Consorcio prisma	
Product Name: Seamless Carbon steel pipes	
Inspector: Jack Xu	
Report approver:	
Inspection type: DUPRO	
Inspection location:	CANGZHOU, HEBEI, CHINA
Inspection date:	22/Mar/2012
Your reference number: N/A	
P/O number: HB2011-12-05	
Buyers: Consorcio prisma	
Supplier: Heibei Zhonghai Steel Pipe Manufacturing Corporation	
Order quantity:	2607.8m/221pcs
Pcs ready for inspection:	2607.8m/221pcs
Reference sample available:	N/A

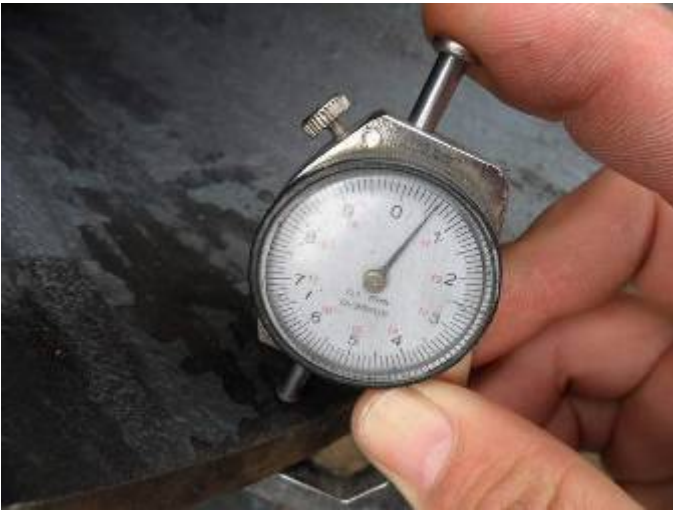
21. Wall thickness test : 10.8mm

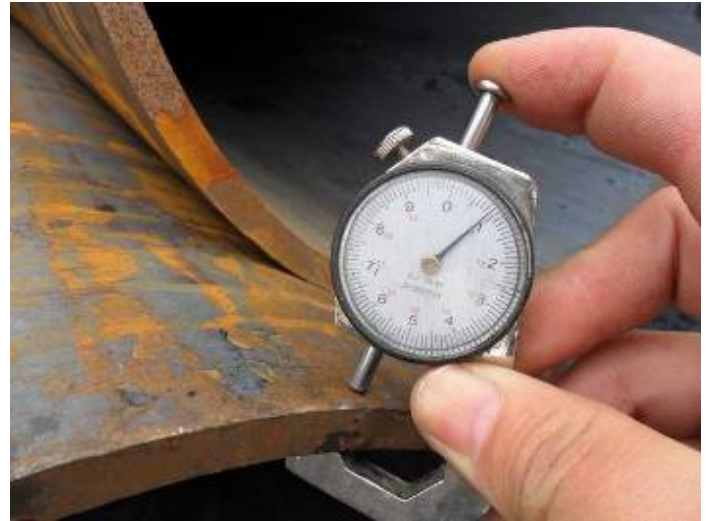
22. Wall thickness test : 10.9mm

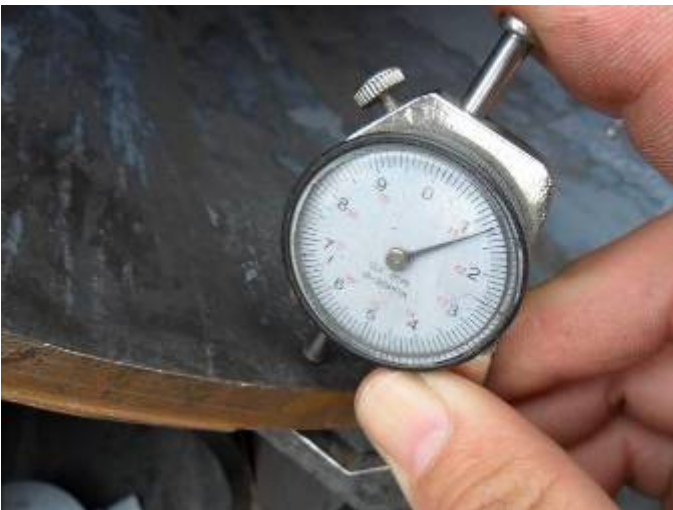
23. Wall thickness test : 11.3mm

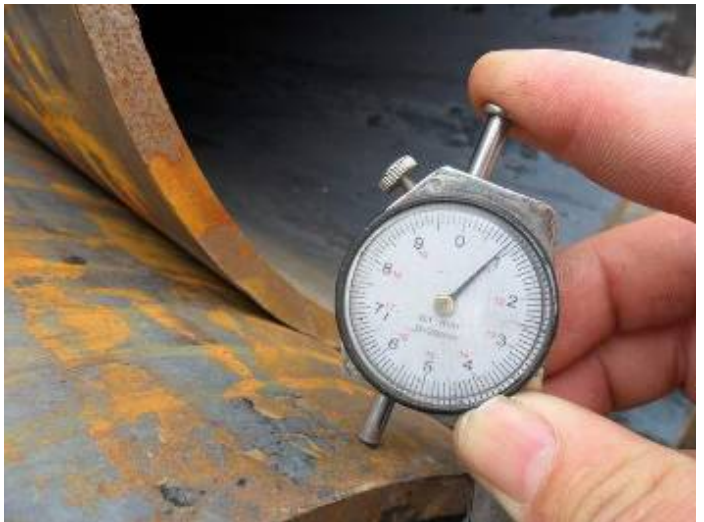
24. Wall thickness test : 10.8mm

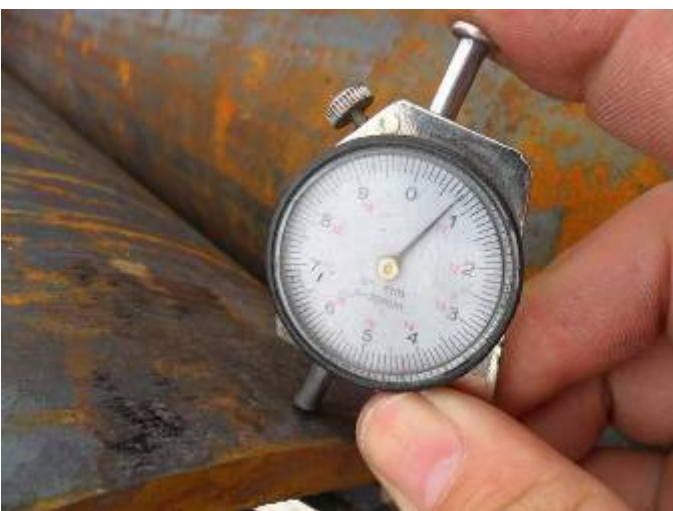
25. Wall thickness test : 10.4mm

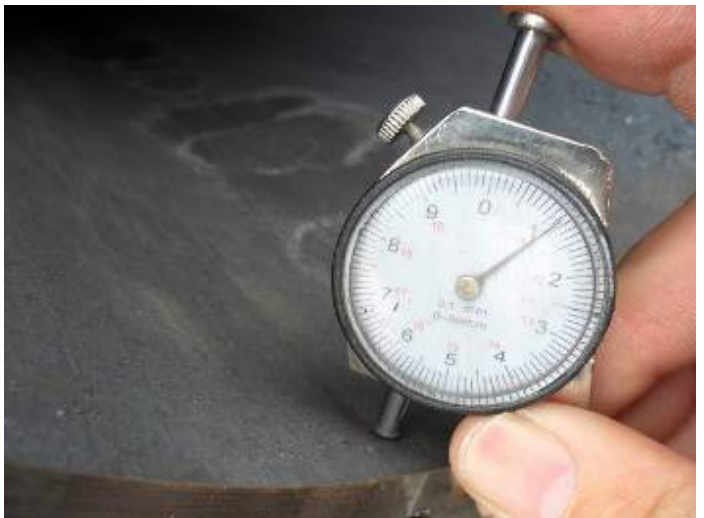
26. Wall thickness test : 10.6mm

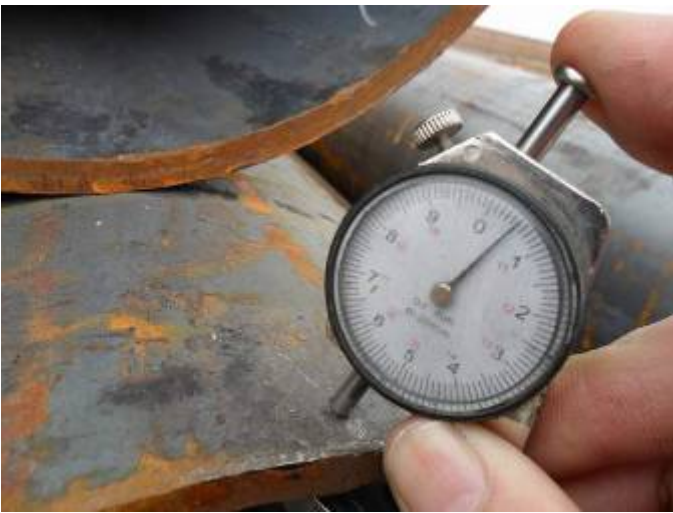
27. Wall thickness test :10 .6mm

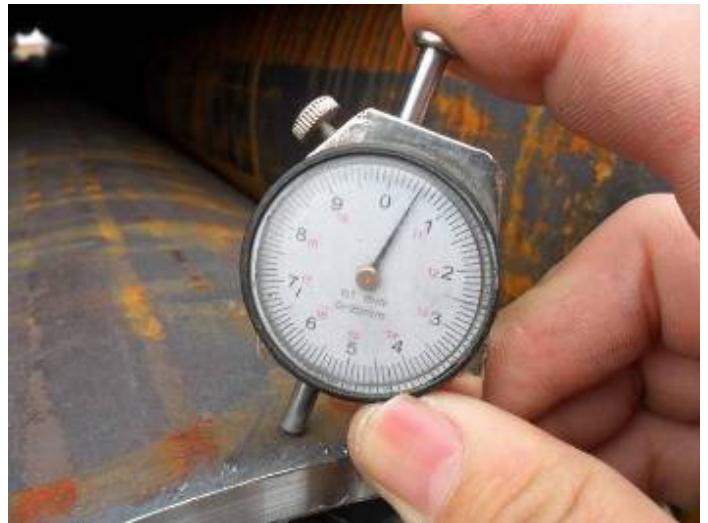
28. Wall thickness test : 10.5mm

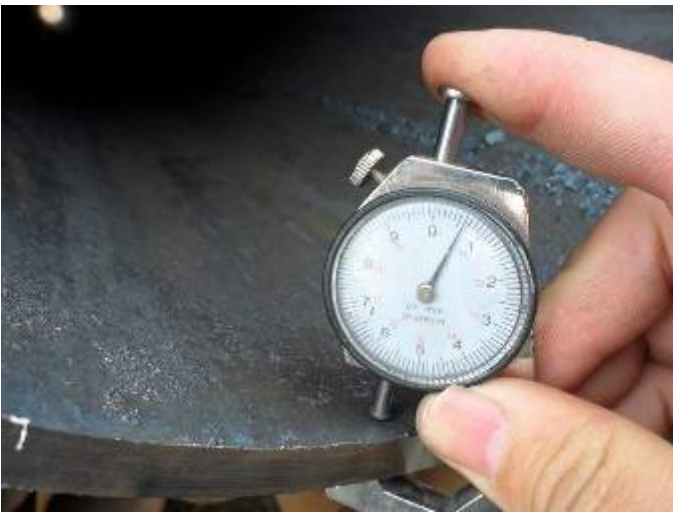
29. Wall thickness test :10.6mm

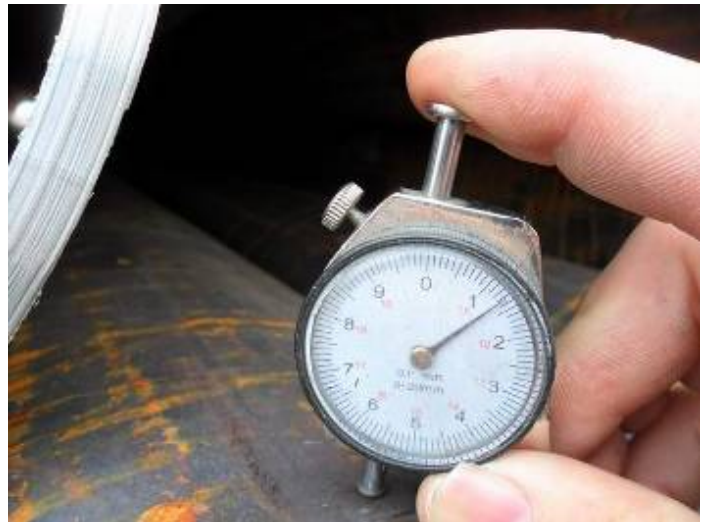
30. Wall thickness test :11.3mm
