Inspection Report

CW-20120319-CLS-001

Client Name: Sultan Triveni General Trading & Contracting	
Product Name: POF centerfolded film	
Inspector: Richard Li	
Report approver:	
Inspection location:	SHENZHEN, GUANGDONG, CHINA
Inspection date:	19/Mar/2012
Your reference number: N/A	
P/O number: ST-044-2011	
Inspection type : Container loading supervision(CLS)	
Supplier: Hubei Guancheng Biodegradable Plastic Products Co. Ltd	
Vendor: Hubei Guancheng Biodegradable Plastic Products Co. Ltd	
Order quantity : 720Rolls	See attached table
Pcs ready for inspection:	100% ready
Reference sample available:	NO

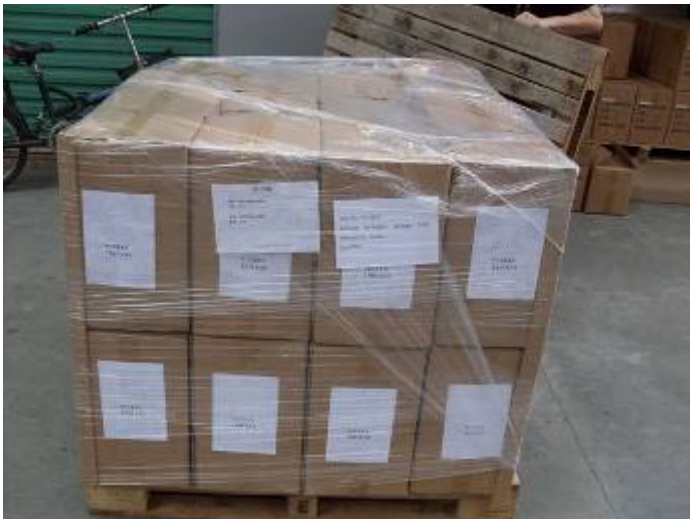
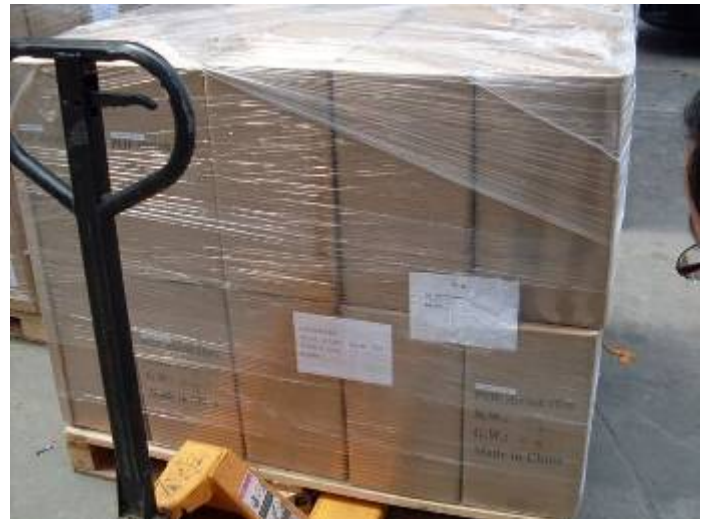
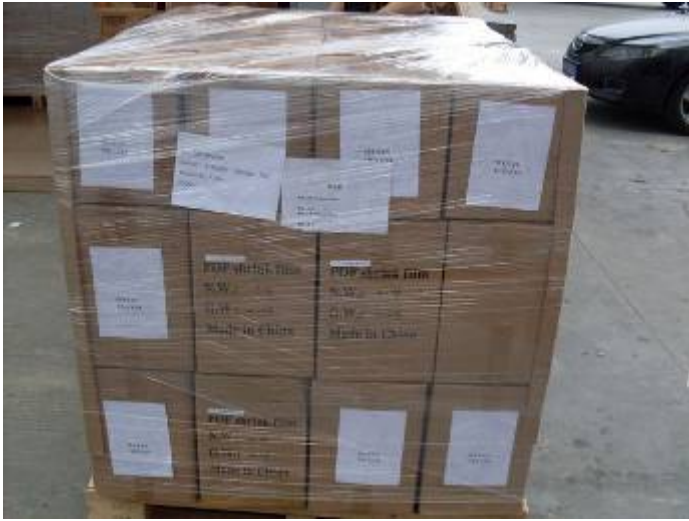
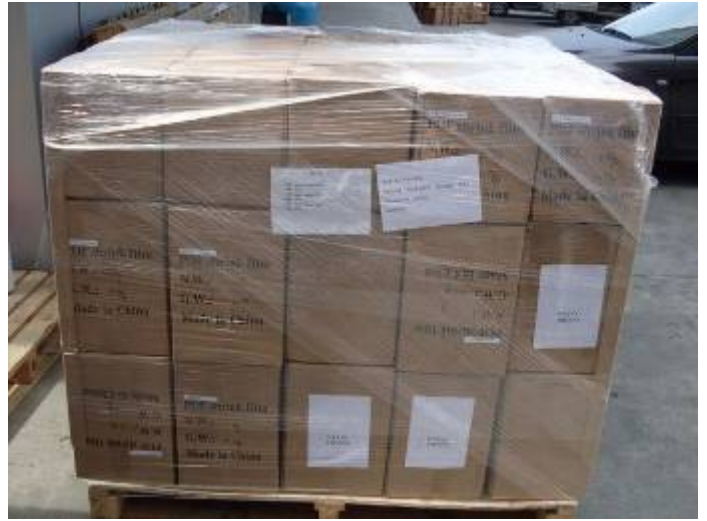
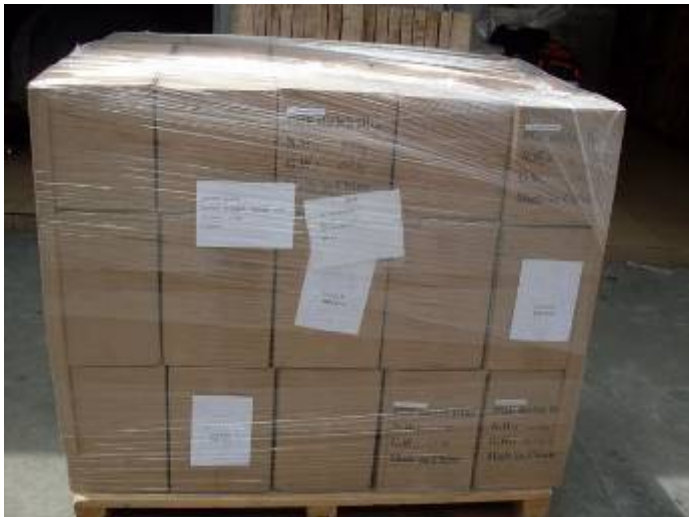
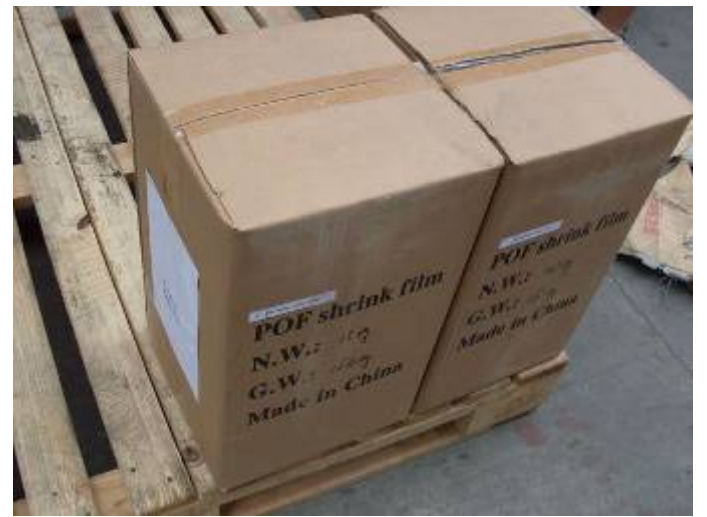
Photos

Sealing method (staples - adhesive - plastic band - metal band): adhesive

Expected Result	Result	Actual Finding / Comments
	Subject to client's decision	Refer to below pictures
