Inspection Report

CW-20120322-DUPRO-001

Client Name: Consorcio prisma	
Product Name: Seamless Carbon steel pipes	
Inspector: Jack Xu	
Report approver:	
Inspection type: DUPRO	
Inspection location:	CANGZHOU, HEBEI, CHINA
Inspection date:	22/Mar/2012
Your reference number: N/A	
P/O number: HB2011-12-05	
Buyers: Consorcio prisma	
Supplier: Heibei Zhonghai Steel Pipe Manufacturing Corporation	
Order quantity:	2607.8m/221pcs
Pcs ready for inspection:	2607.8m/221pcs
Reference sample available:	N/A

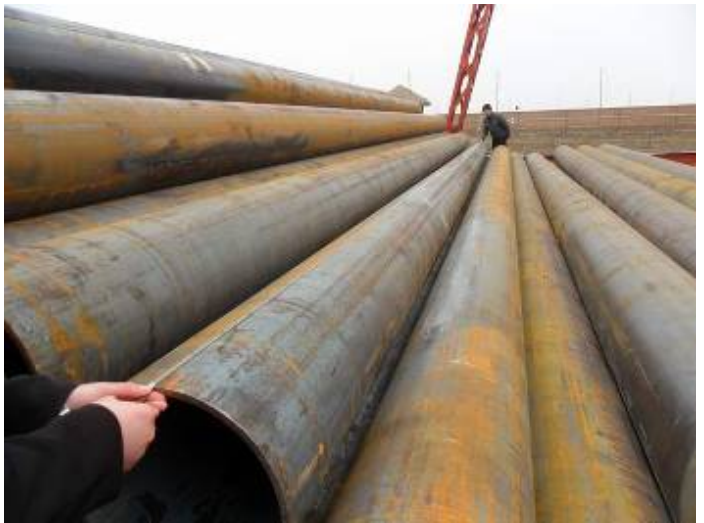
10. Length testing

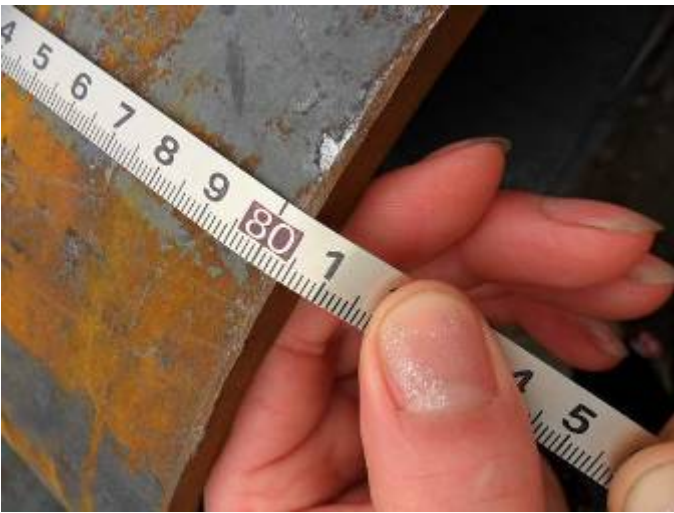
11. Length test : 11805mm

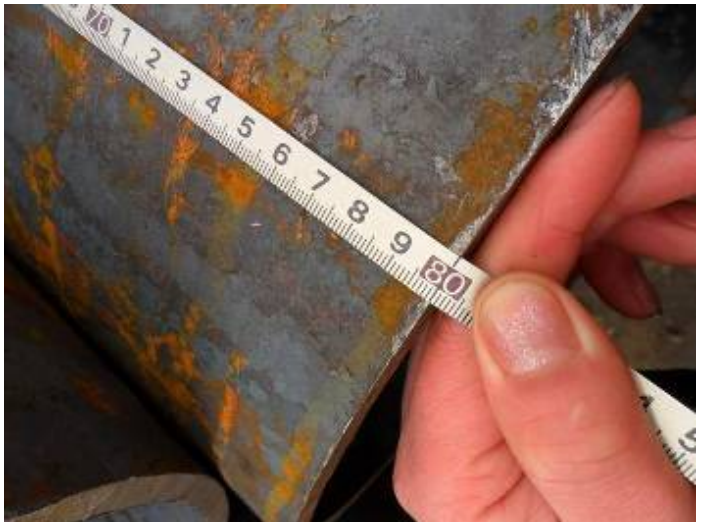
12. Length test: 11800mm

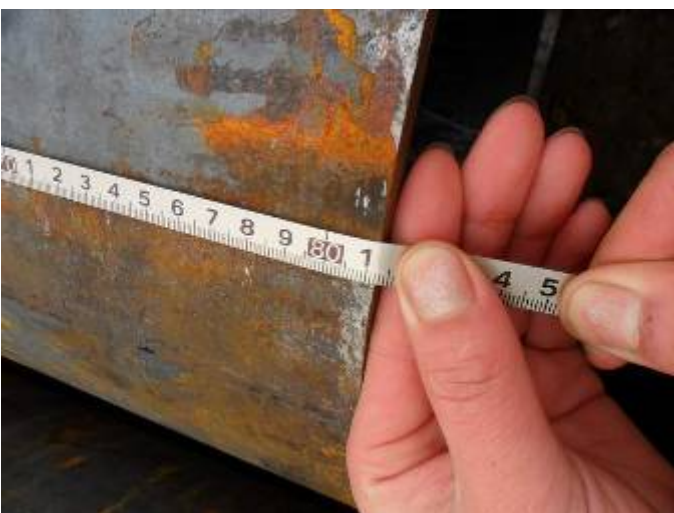
13. Length test : 11812mm

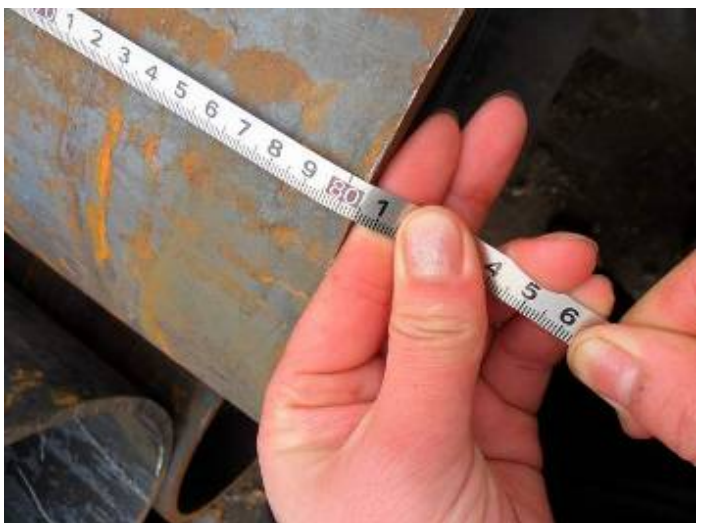
14. Length test : 11806mm

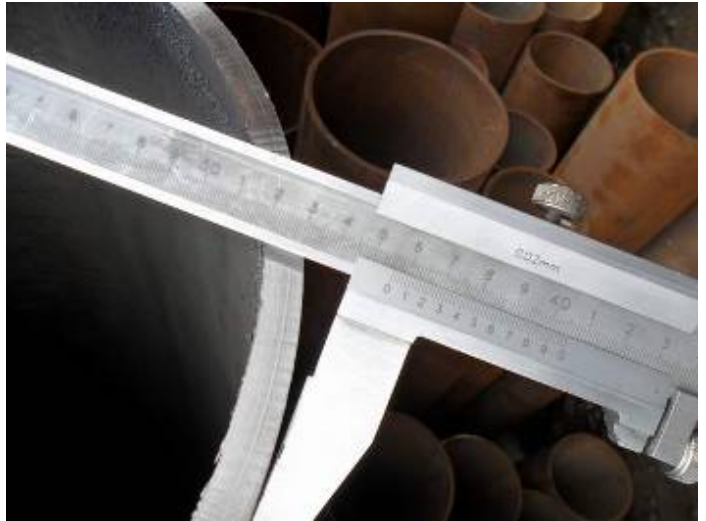
16. Outside diameter : 356.6mm

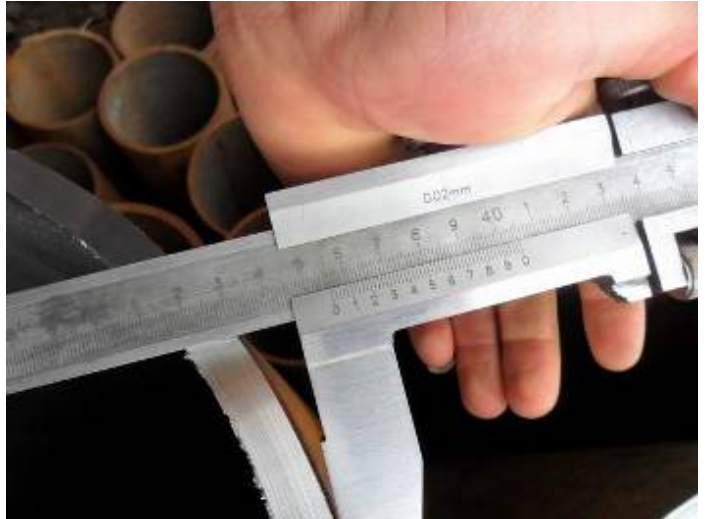
18. Outside diameter : 356mm

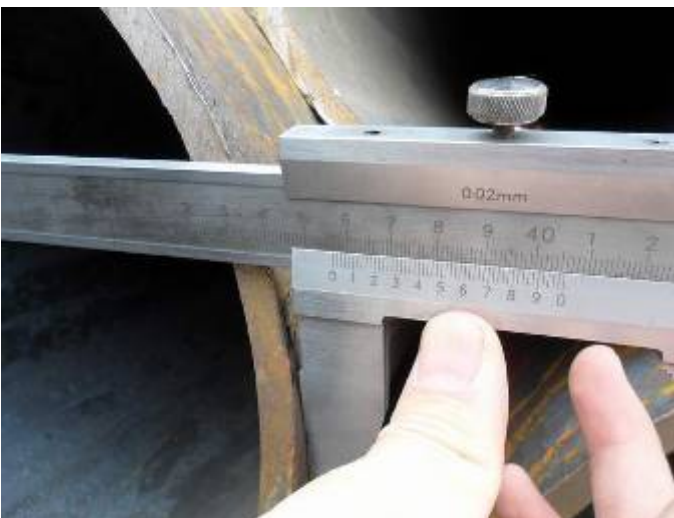
19. Outside diameter : 356.0mm

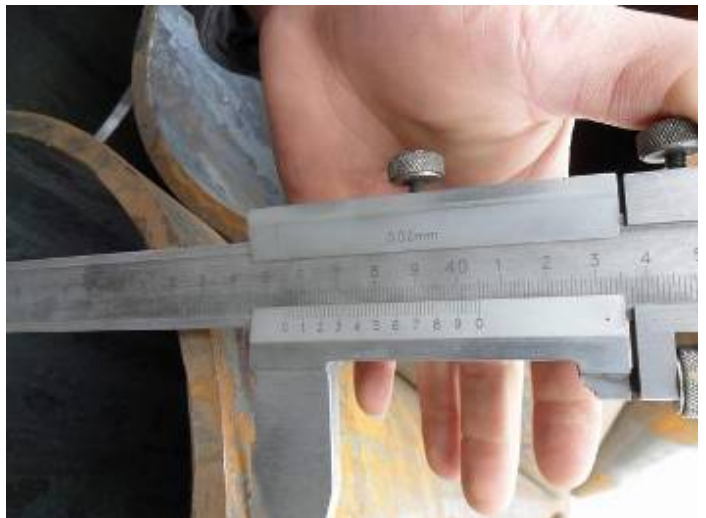
20. Outside diameter : 356.1mm

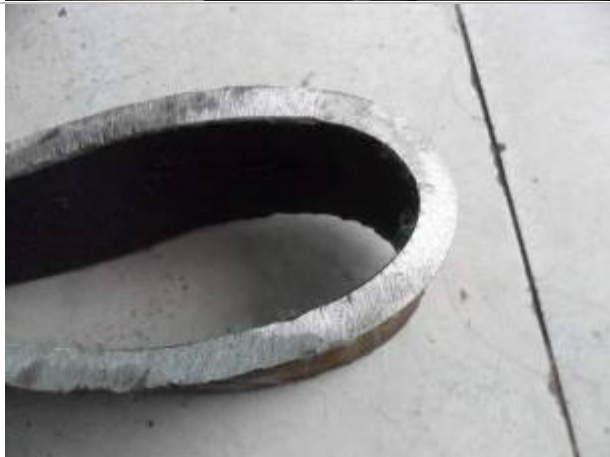
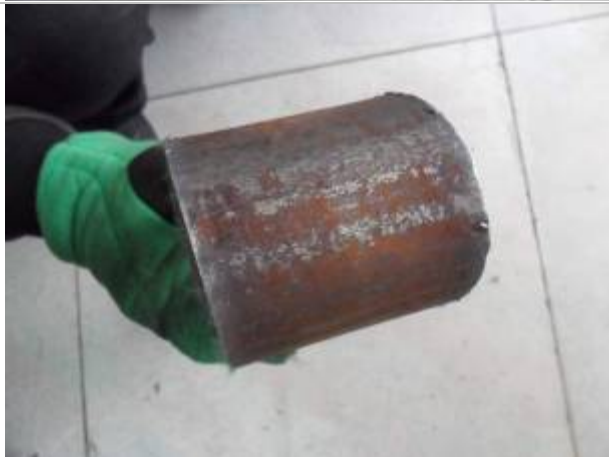
3.Pull test --S1

Check 1pc per items

passed
